# Manhole Inspection Summary

Manhole # S39MM\_035MH

Insp Date: **2/5/07 2:43 PM**

**Location** Address: **1138 NORTH AVE**

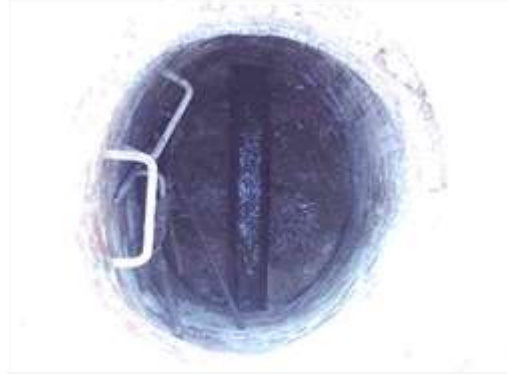
Top View

Evidence of surcharge - Bench debris.

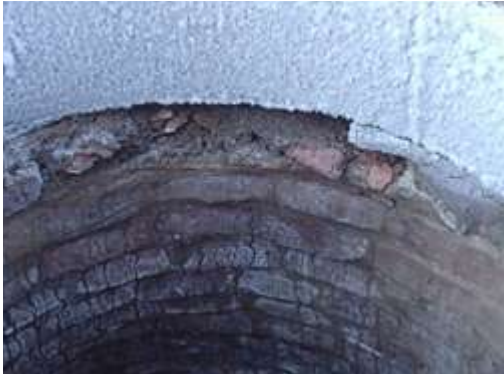
Defect

Frame leaks. Frame offset. Adjustment deterioration and infiltration. Corbel infiltration - other side.

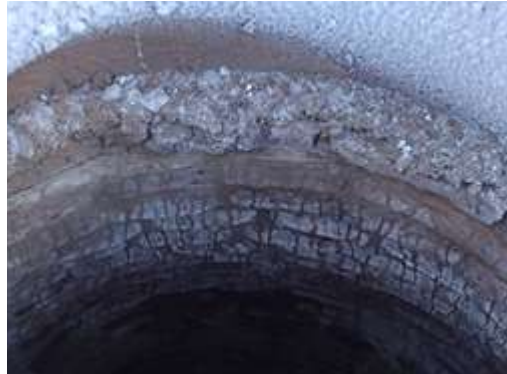
Defect

Frame leaks. Frame offset. Adjustment deterioration and infiltration. Corbel and Barrel infiltration.

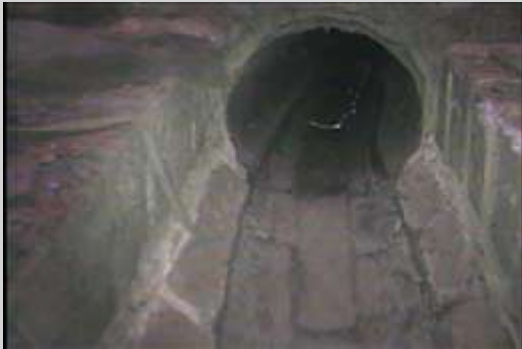
### 8 in. Circular Gravity Sewer Pipe Out @ 12 O'Clock

Infiltration: **Evidence** Pipe Seal Cond: **Unknown**
